AIRCRAFT ACCIDENT REPORT

1. AIRCRAFT ACCIDENT BOARD APPOINTED BY C.O. FITRON NINE TWO	2. SERIAL NO. 1-64A	3. DTG (LOCAL) OF MIDWAT 121257U Feb	4. MODEL AIRCRAFT F4B	5. BUREAU NUMBER 149454
6. LOCATION OF MIDWAT TO: Commander, Naval Aviation Safety Center	7. LOCATION OF MIDWAT 230°M 65°N NAS Miramar	8. DAMAGE ALPHA		
9. VIA: C.O. FITRON NINE TWO COMCARAIRWING NINE COMFAIRSAN DIEGO COMNAVAIRPAC	10. TIME OF DAY Day	11. TIME IN FLIGHT 01 + 24	12. FLIGHT CODE 1A6	
13. CLEARED FROM: NAS Miramar TO: NAS Miramar		14. TYPE CLEARANCE VFR Local	15. AIRSPEED 300 E	16. A/C WEIGHT 38,000
17. BRIEF DESCRIPTION OF MIDWAT Left roll through inverted position. Collision with water, uncontrolled.		18. ELEVATION AT TIME OF MIDWAT S.L. 0	TERRAIN	
19. LIST MODEL, BURO, REPORTING CUSTODIAN AND DAMAGE CLASSIFICATION OF ANY OTHER A/C INVOLVED (Complete OPNAV Form 3750-3 for each A/C)

PART V THE ACCIDENT

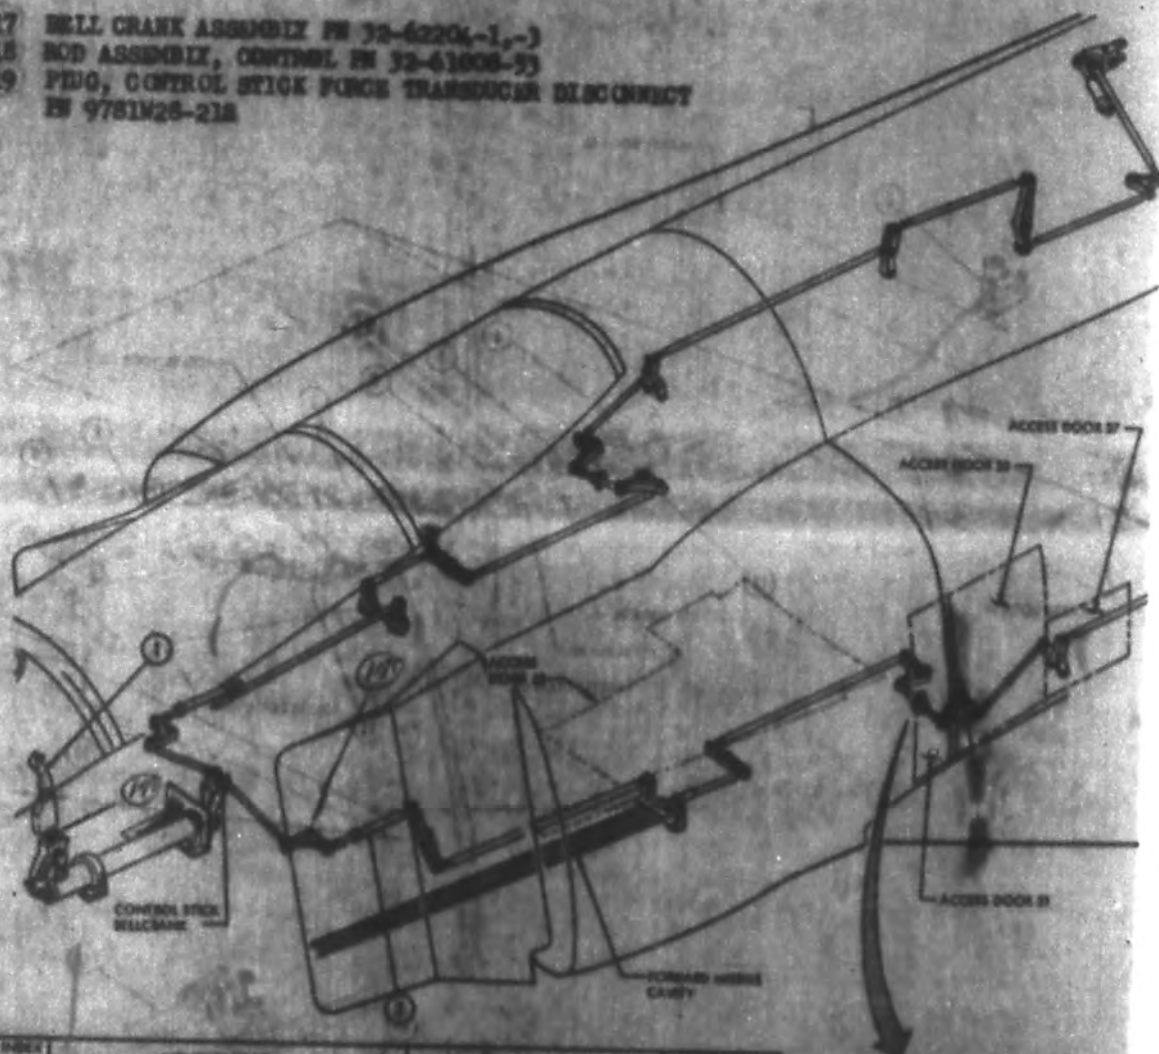
VF-92 AAR 1-64, A encl. (17)

Shortly thereafter LTJG RENEAU asked LT BUTNER to jot down that the stick had $\frac{1}{2}$ to $\frac{3}{4}$ inch side play. This was the source of some concern to LT BUTNER. (Eight days before a pilot had downed an aircraft for too much stick play, and maintenance had found the cannon plug at the base of the force transducer loose and ready to disconnect. See enclosure 15).

- 17 BELL CRANK ASSEMBLY PN 32-62204-1,-3)
 18 ROD ASSEMBLY, CONTROL PN 32-61008-33
 19 PISO, CONTROL STICK FORCE TRANSDUCER DISCONNECT
 PN 9781N28-218

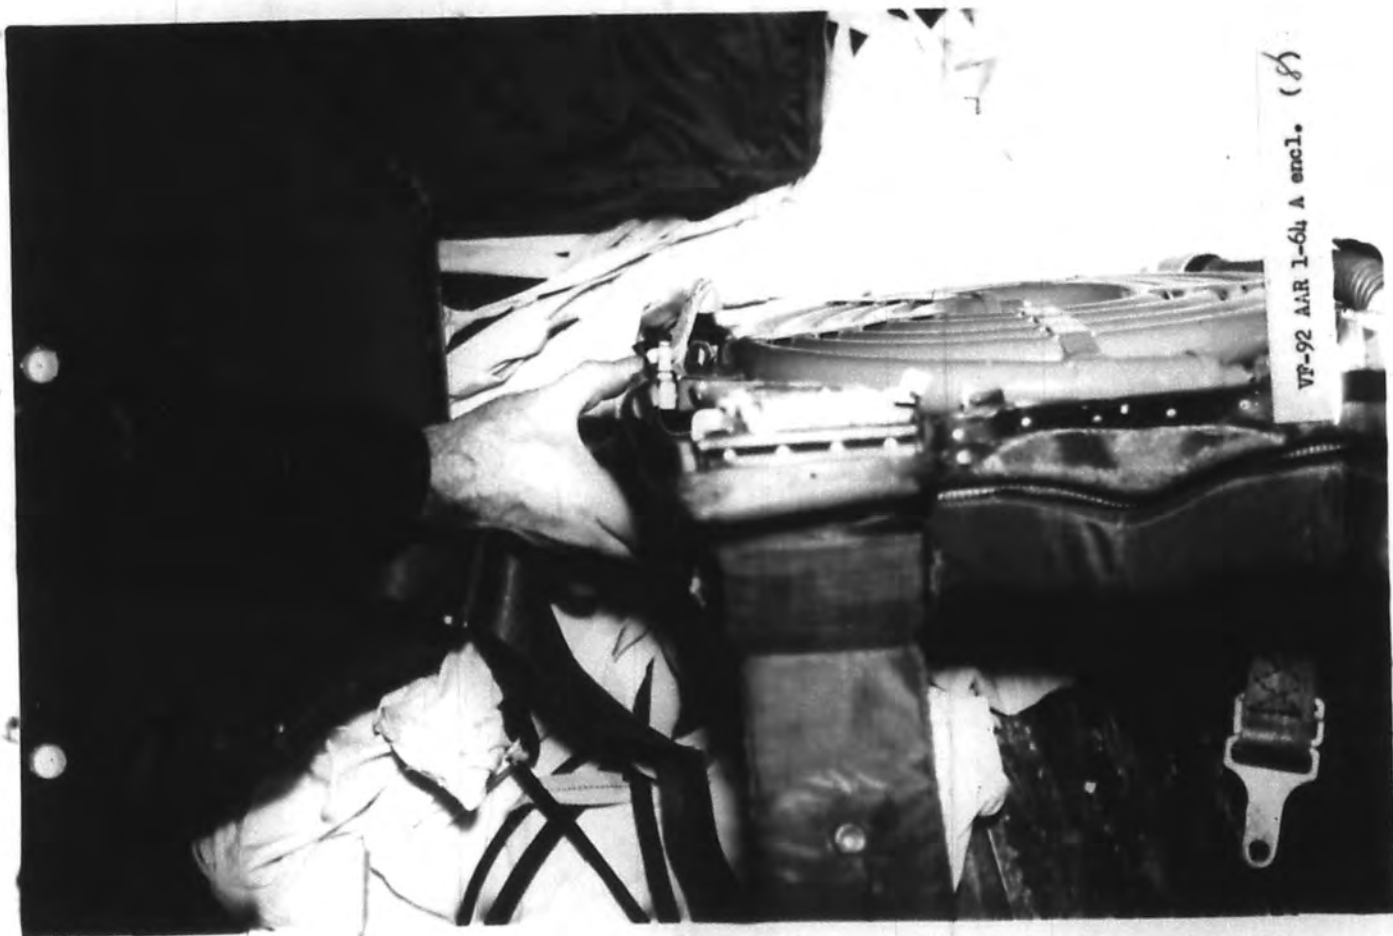
VF-92 AAR SER:

VF-92 AAR SERIAL: 1-64A; 12 FEB 64; P4B, HUNO: 149454; PILOT: RENEAU.
TOP HALF OF PILOT'S SCOTT PAN (NO 209) THUMB POINTS TO LUG SHOWING
DISTORTION.
SPECIAL HANDLING REQUIRED IN ACCORDANCE WITH PARA 64 OPNAVINST, P3750-6E

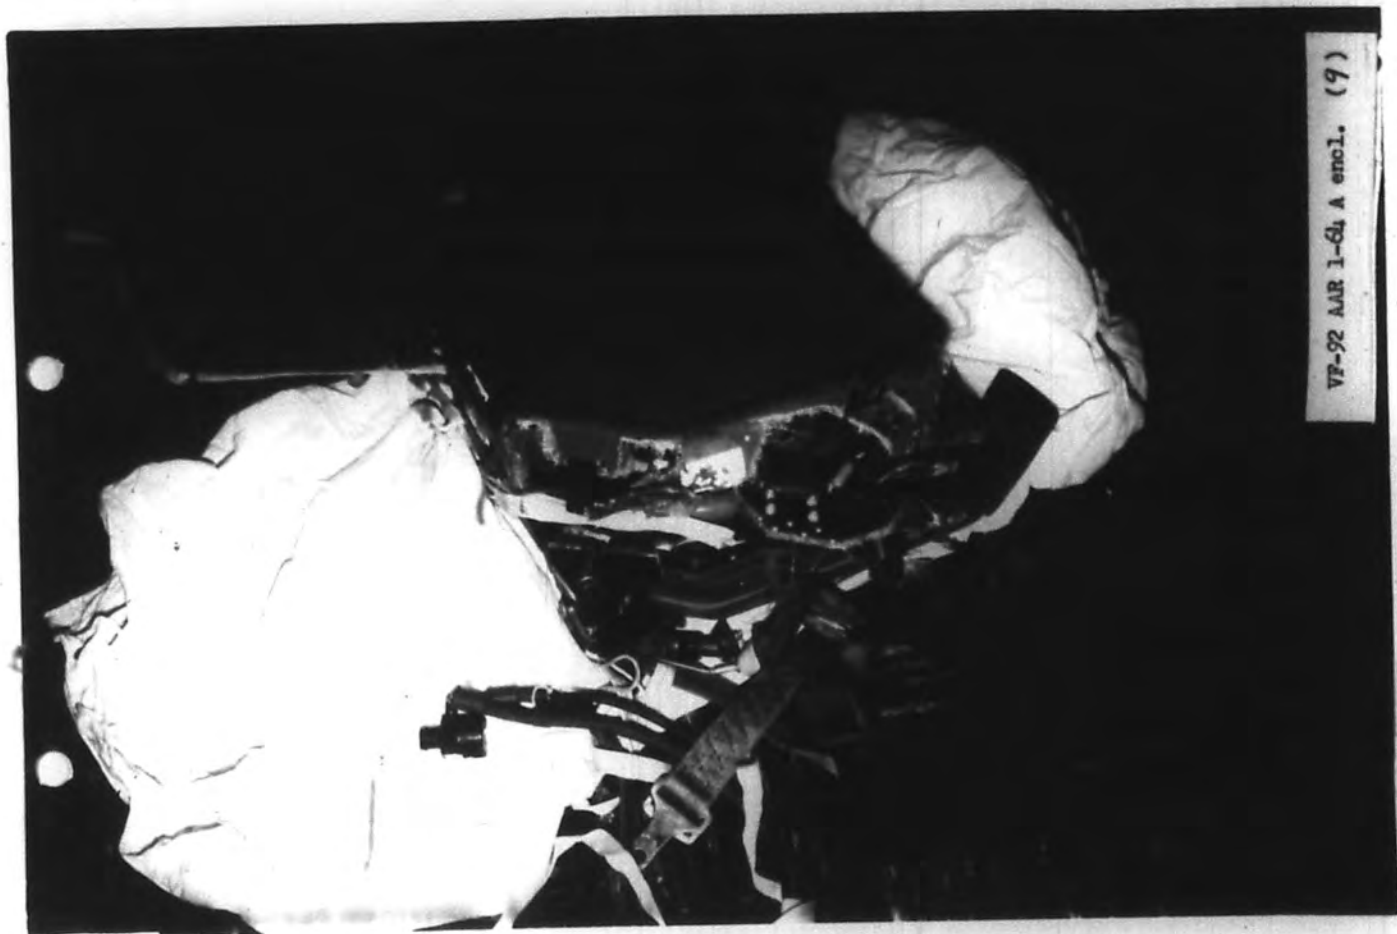
VF-92 AAR SER:

VF-92 AAR SERIAL: 1-64A; 12 FEB 64; F4B, HUNO: 149454; PILOT: RENEAU.
PILOT'S SCOTT PAN BOTTOM HALF. ARROW INDICATES CUT PORTION.
SPECIAL HANDLING REQUIRED IN ACCORDANCE WITH PARA 66 OPNAVINST, P3750-6E

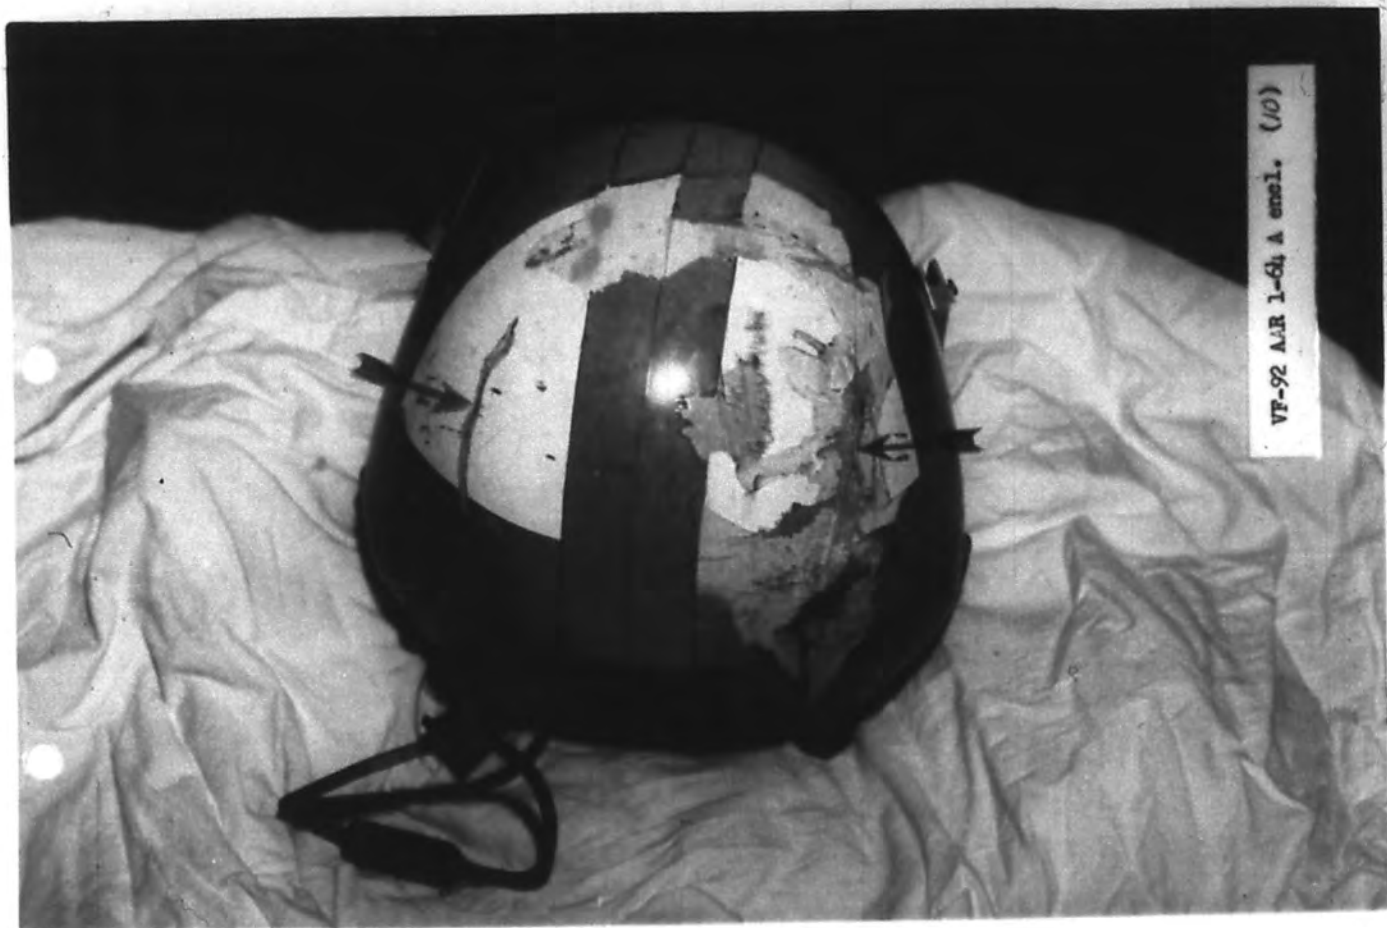
VF-92 AAR SER:

VF-92 AAR SERIAL: 1-64A; 12FEB 64; F4B, BUNO: 149454; PILOT: RENEAU.
PILOT'S APH-5 HELMET (NG 209) ARROWS POINT OUT SCRATCHES 5 $\frac{1}{2}$ INCHES APART.
SPECIAL HANDLING REQUIRED IN ACCORDANCE WITH PARA 66 OPNAVINST, P3750-6E

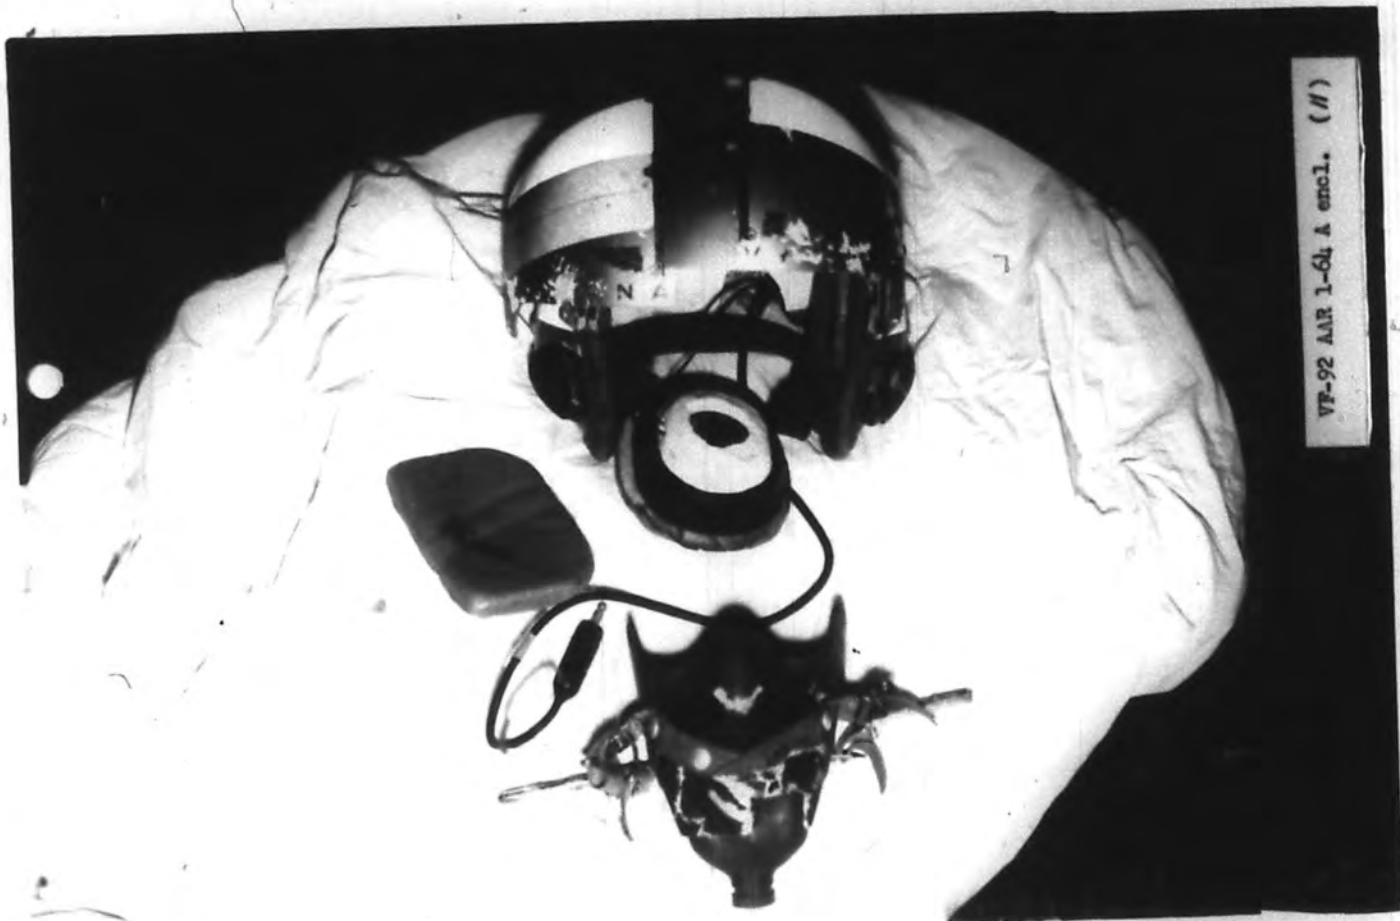
VP-92 AAR SER:

VP-92 AAR SERIAL: 1-64A; 12 FEB 64; P4B, BUNO: 149454; PILOT: RENEAU.
PILOT'S HELMET AND OXYGEN MASK (NG 209) SHOWS IMPACT DAMAGE.
SPECIAL HANDLING REQUIRED IN ACCORDANCE WITH PARA 66 OPNAVINST, P3750-6E

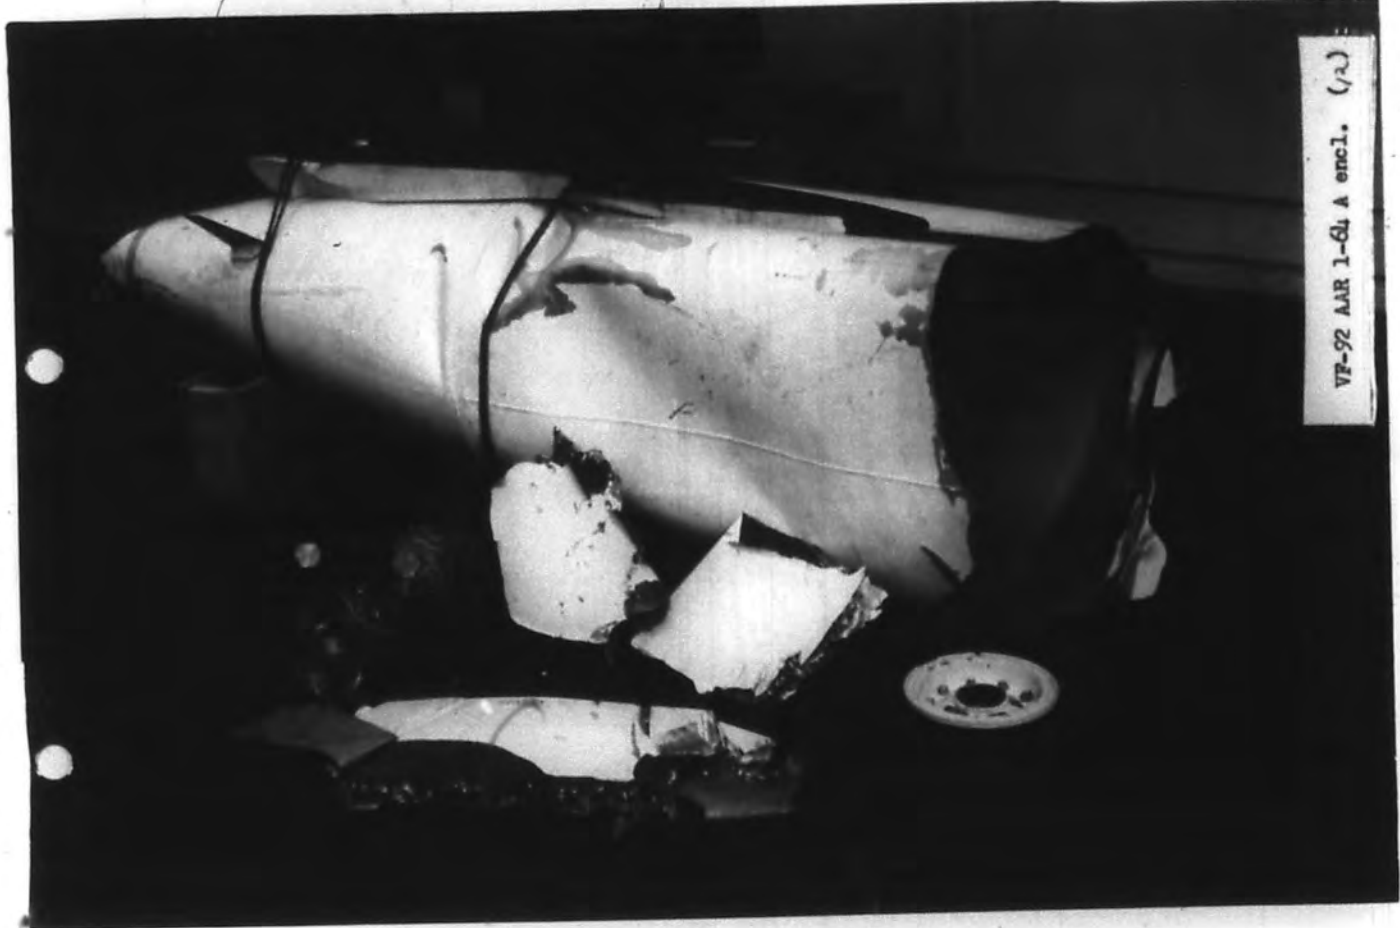
VF-92 AAR Serial:1-64A; 12 Feb 64; F4B, BuNo: 149454; Pilot: Reneau
Total debris recovered. Portion of 600 gallon centerline tank split at rear attaching lug.
Two high pressure air bottles. Portions of wing structure honeycomb. Nose tire.
Special Handling required in accordance with Para 66 OpNavInst P3750.6E.

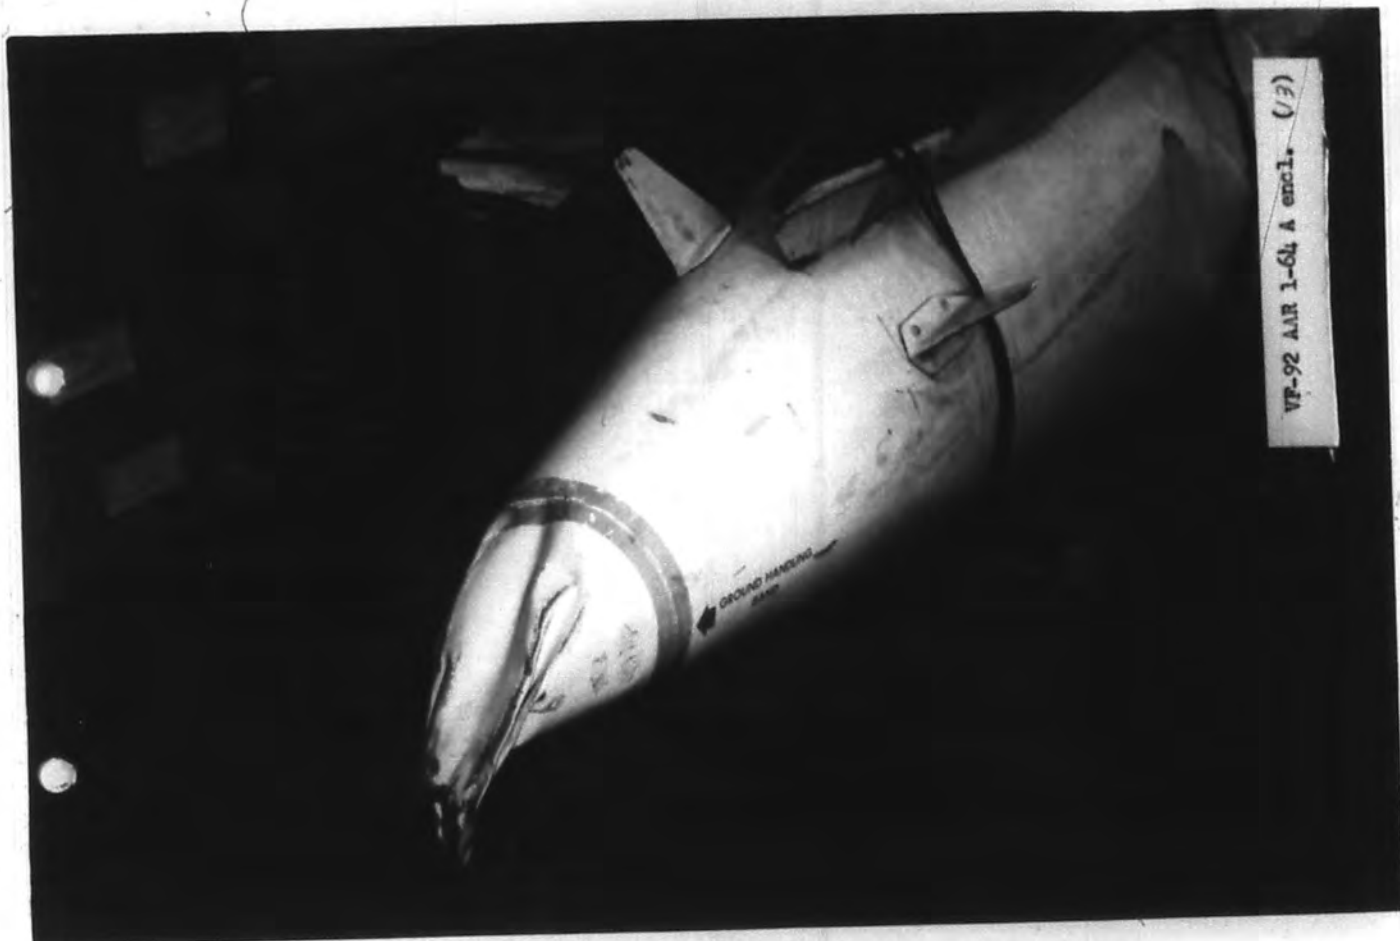
VF-92 AAR Serial:1-64A; 12 Feb 64; F4B, BuNo: 149454; Pilot: Reneau
Aft tip of 600 gallon centerline tank showing damage from collision with under fuselage.
Special Handling required in accordance with Para 66 OpNavInst P3750.6E.

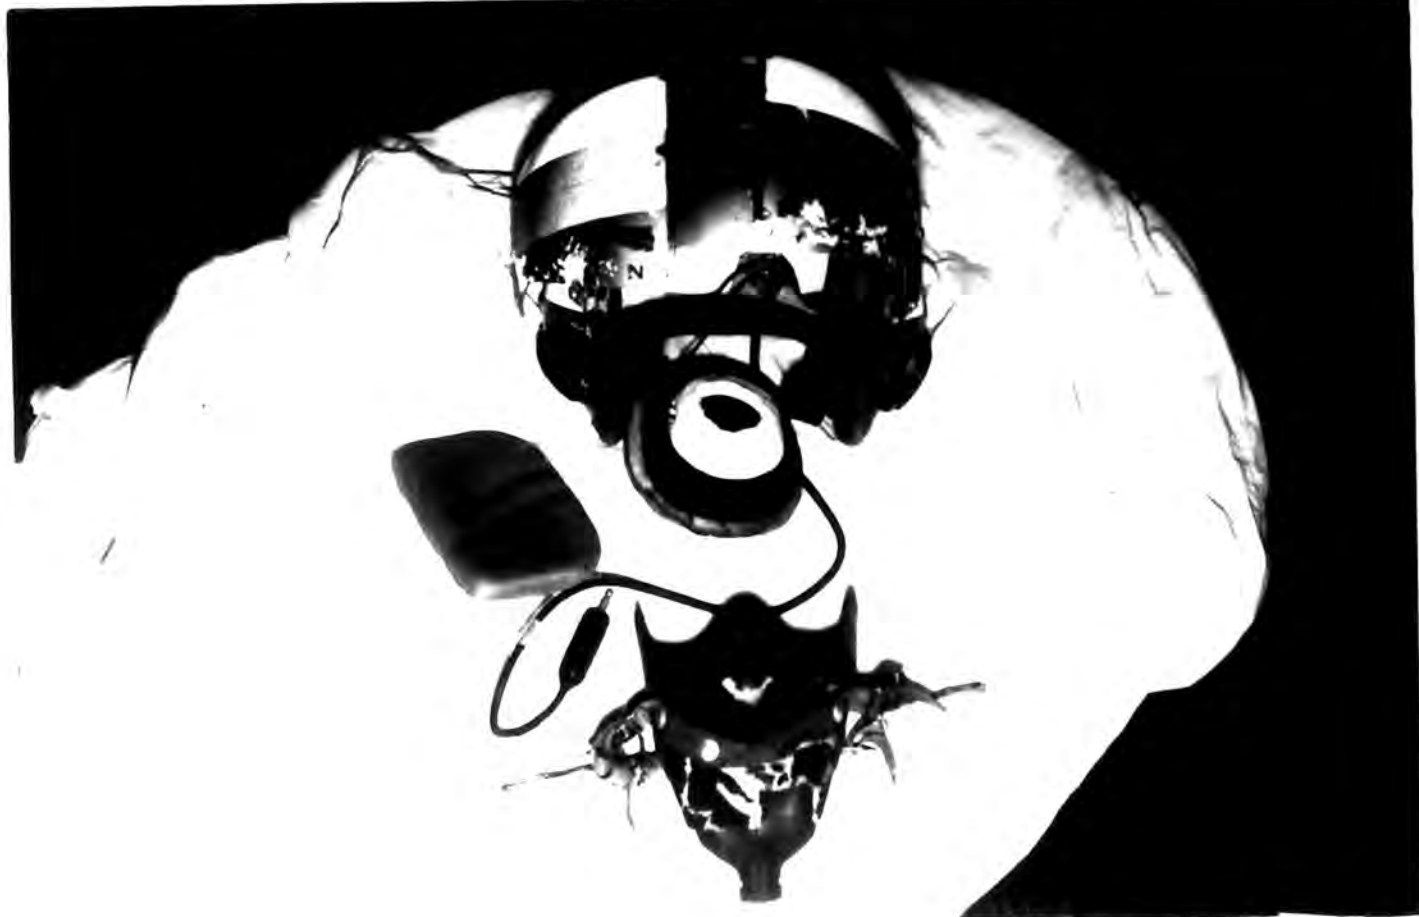
VP-92 AAR SER:

VP-92 AAR SERIAL: 1-64A; 12 FEB 64; P4B, BUMO: 149454; PILOT: RENEAU.
PILOT'S HELMET AND OXYGEN MASK (NG 209) SHOWS IMPACT DAMAGE.
SPECIAL HANDLING REQUIRED IN ACCORDANCE WITH PARA 66 OPMVINST, P3750-6E

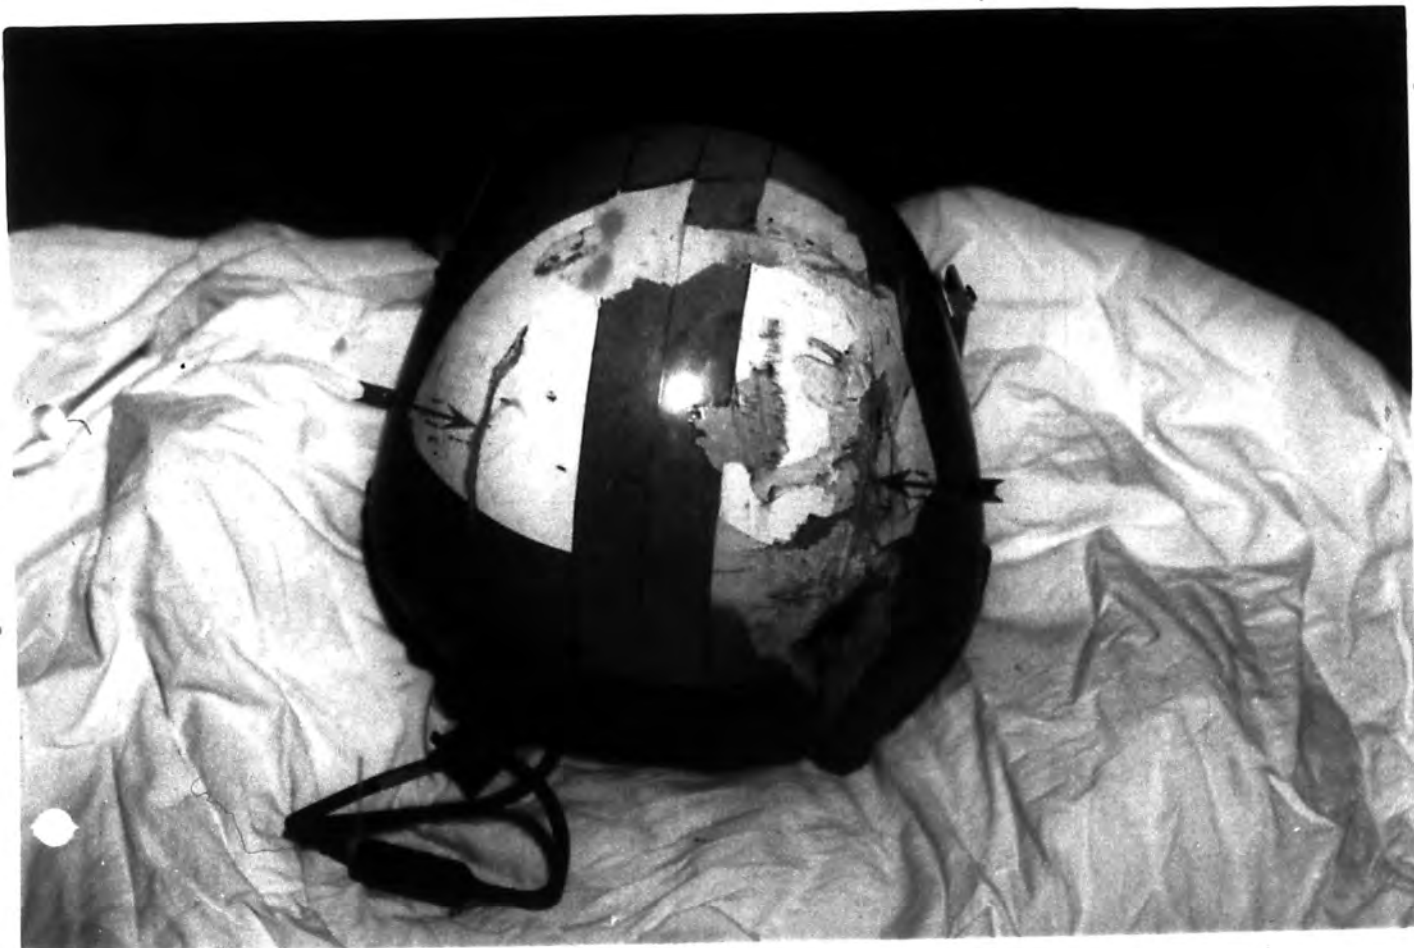
VP-92 AAR SER:

VP-92 AAR SERIAL: 1-64A; 12 FEB 64; F4B, HUNO: 149454; PILOT: RENEAU.
PILOT'S ACH-5 HELMET (NG 209) ARROWS POINT OUT SCRATCHES 5½ INCHES APART.
SPECIAL HANDLING REQUIRED IN ACCORDANCE WITH PARA 66 OPNAVINST, P3750-6E

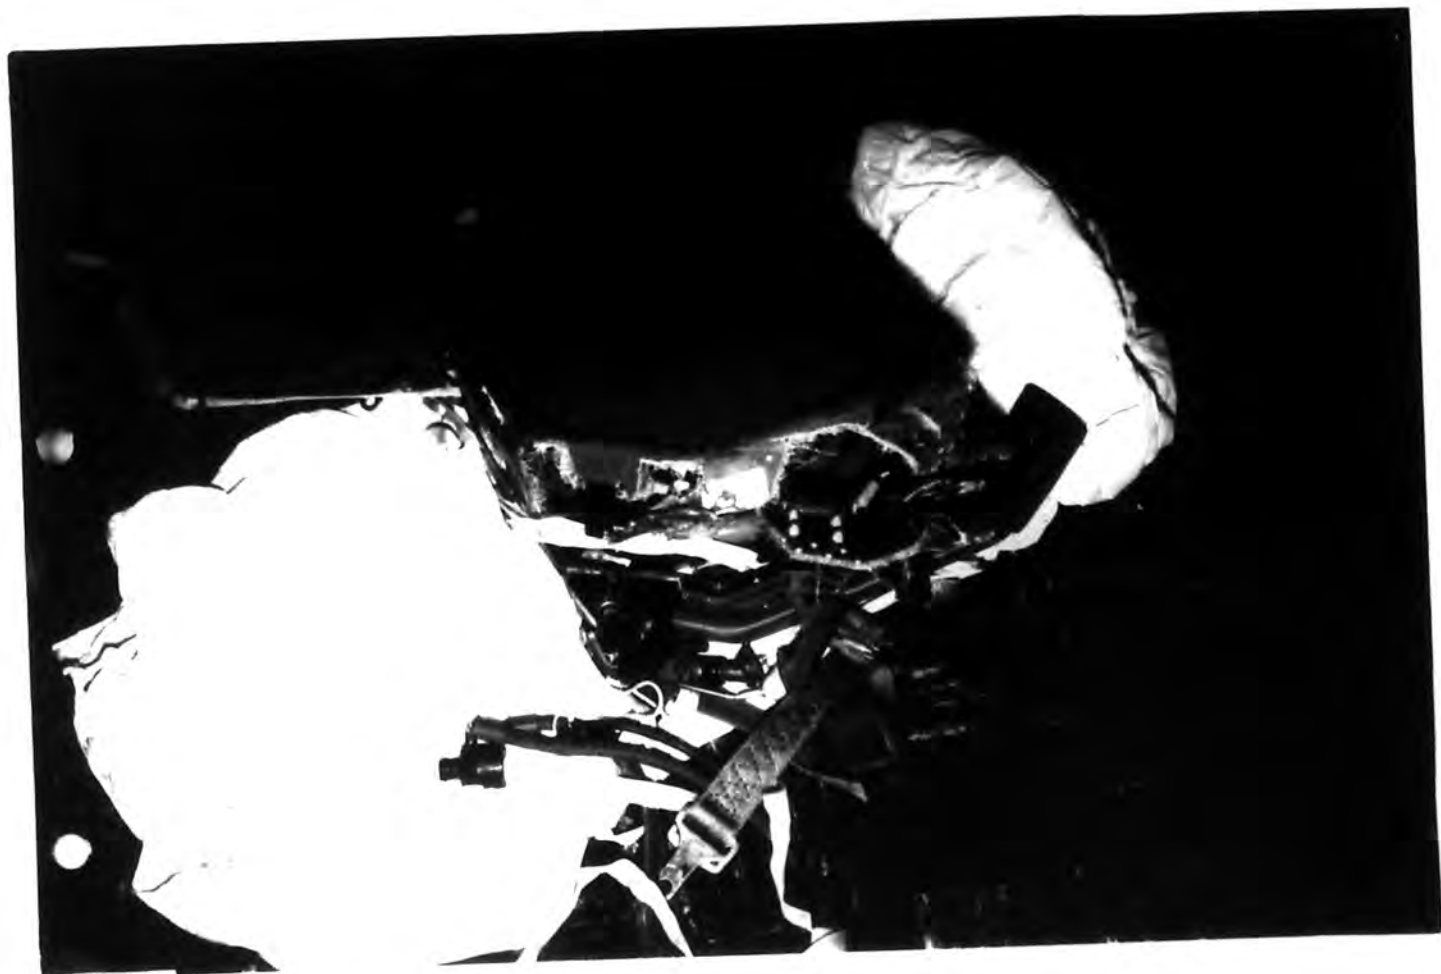
VP-92 AAR 12:

VP-92 AAR SERIAL: 1-64A; 12 FEB 64; P4B, BUNO: 149454; PILOT: RENEAU.
PILOT'S SCOTT PAN BOTTOM HALF. ARROW INDICATES CUT PORTION.
SPECIAL HANDLING REQUIRED IN ACCORDANCE WITH PARA 66 OPNAVINST, P3750-6E
